Phase II Evaluation of a 30-mm Thin Wall Steel Cartridge Case

TECHNICAL REPORT ADTC-TR-79-2

FEBRUARY 1979

3246TH TEST WING
ARMAMENT DEVELOPMENT AND TEST CENTER

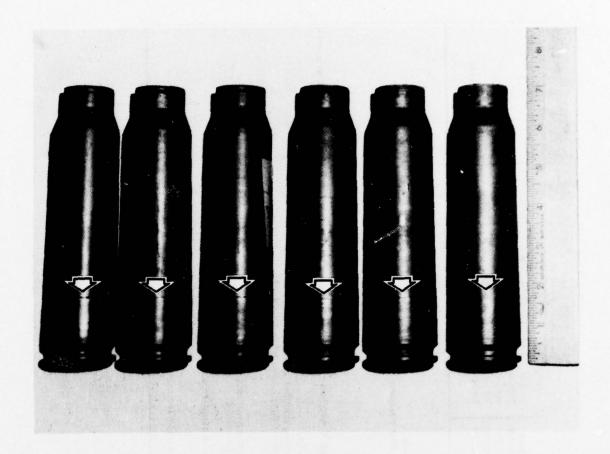
Two steel case rounds per barrel were fired at low rate. Two of the 14 rounds misfired due to a firing pin malfunction resulting in light strikes on the primers. Each steel case split when fired at low rate (Figure 4). One round was fired at high rate to confirm that the problem also existed at that condition. This steel case round was almost completely severed.

Figure 4. First six cases (Group A) of 14 fired at low rate showing (arrows) circumferential split approximately 1 5/8 inches from the base

After examining the split cases, four steel case rounds were coated with light oil in an attempt to reduce the friction forces between the case and chamber. Two rounds were fired at low rate, with no splitting occurring. Subsequently, one oiled round and one dry round were fired at high rate. The oiled round did not split but the dry round did. Another oiled round was fired at high rate in the same barrel as the previous dry round. This oiled round did not split.

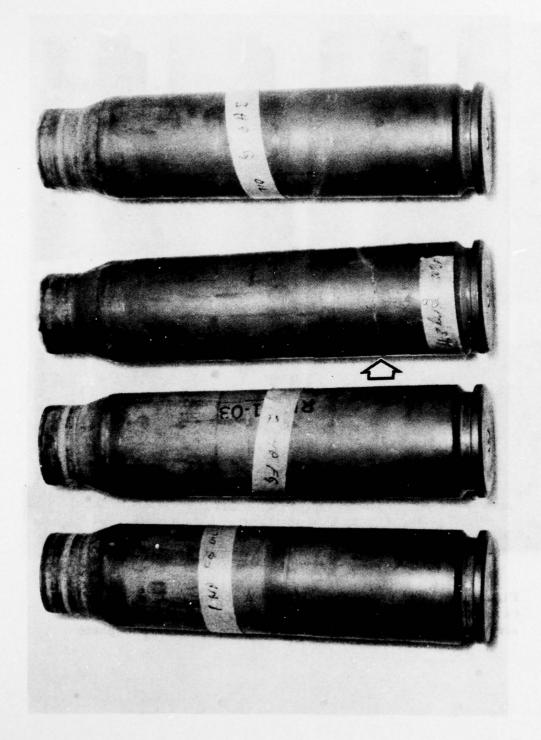
Figure 6. Three steel case rounds from Group B loaded for high pressure and one reduced hardness steel case with 30 percent Teflon over phosphate showing crack (arrow)

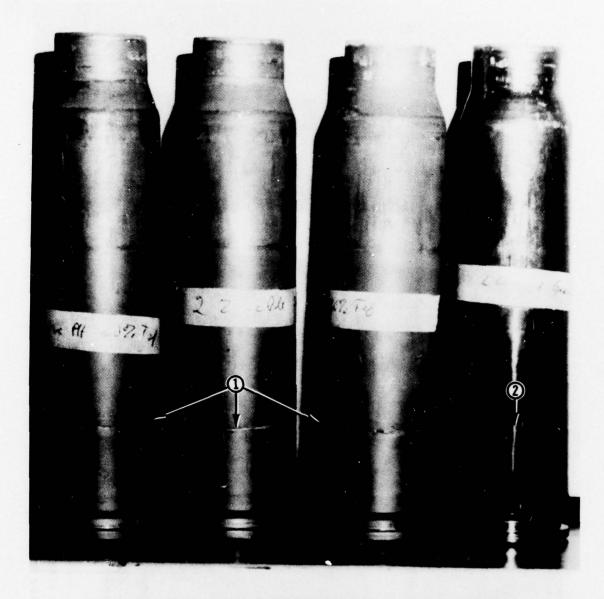
Figure 7. Four cases from Group B showing (1) cracks in cases coated with 30 percent Teflon over zinc plate and (2) stretch in a case coated with Mader lacquer over phosphate
